**Flood Control Project Maintenance  
Levee Inspections**  
**LMA District Cover Sheet**  
**Spring 2011 Levee Inspection Results**

**Reclamation District No. 2063 Crows Landing**

**Levee Inspection Report By Mile - Spring 2011**

Waterway	Bank	Unit Miles	Inspection Start/End	Inspector
Unit No. 01 San Joaquin River	Right	10.63	05/18/2011 05/18/2011	Richard Willoughby

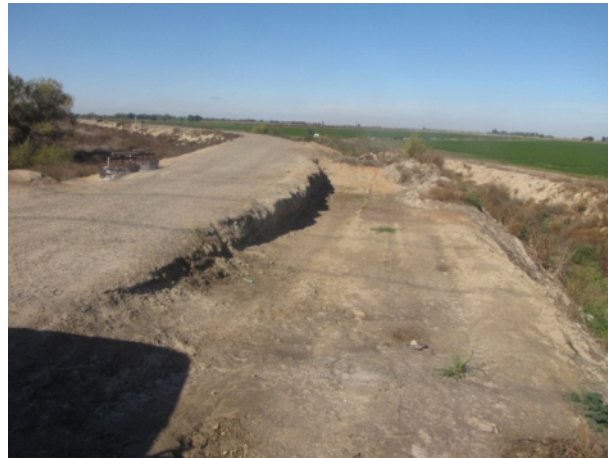
Levee Mile Report Line	6
Start Levee Mile	1.35
End Levee Mile	1.35
Location	Land Side
Category	Earthen Levee
Item	Encroachments

6	1.35	1.35	Earthen Levee	Encroachments	LS	CO	Ramp Inspector Comments: Ramp does not meet CVFPB standards. Ramp has 18-20" vertical cut at landside shoulder.	37.464308 ° -121.032603 °	37.464308 ° -121.032603 °	6 Y
7	1.47	1.50	Earthen Levee	Vegetation	LS	W	Remove the wild growth other than native grasses from the levee slopes.	37.462723 ° -121.032020 °	37.462303 ° -121.031928 °	8
8	1.54	1.54	Earthen Levee	Slope Stability	LS	M	Repair the levee slope damaged by vehicle traffic and prevent access where possible.	37.461762 ° -121.031822 °	37.461762 ° -121.031822 °	10 Y
9	1.57	1.57	Earthen Levee	Animal Control	LS	M	Exterminate rodents and backfill and compact or grout burrows.	37.461322 ° -121.031785 °	37.461322 ° -121.031785 °	4
10	1.69	1.69	Earthen Levee	Animal Control	LS	M	No rodents visible, but rodent burrows visible; need to backfill and compact or grout burrows.	37.459813 ° -121.032372 °	37.459813 ° -121.032372 °	11 Y

Looking north at ramp and equipment working pad on landside slope with a 18-20" vertical cut at shoulder.

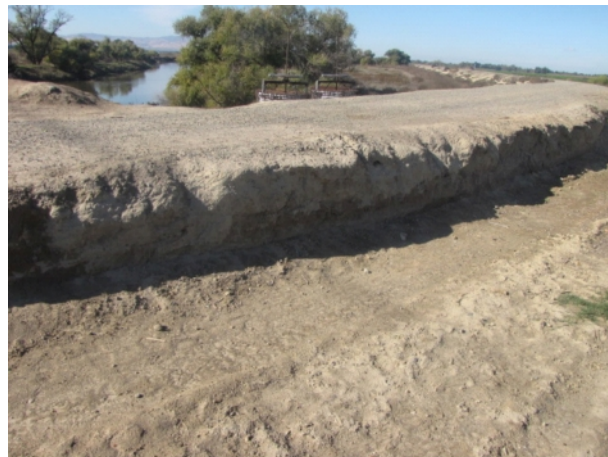
Levee Mile Report Line	6
Start Levee Mile	1.35
End Levee Mile	1.35
Location	Land Side
Category	Earthen Levee
Item	Encroachments

Looking west at 18-20" vertical cut for ramp on landside shoulder and slope

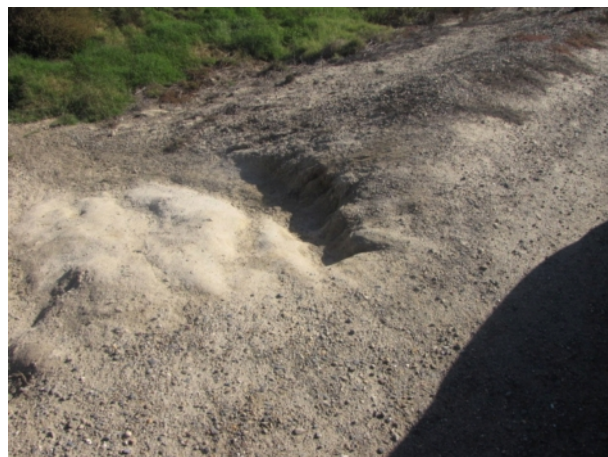
Levee Mile Report Line	8
Start Levee Mile	1.54
End Levee Mile	1.54
Location	Land Side
Category	Earthen Levee
Item	Slope Stability

Looking east at landside slope damage (six to eight inch erosion) by vehicle

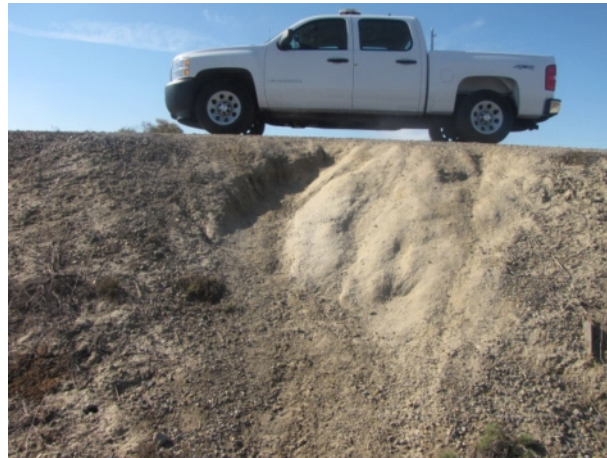
Levee Mile Report Line	8
Start Levee Mile	1.54
End Levee Mile	1.54
Location	Land Side
Category	Earthen Levee
Item	Slope Stability

Looking west at landside slope damage cause by vehicle traffic.

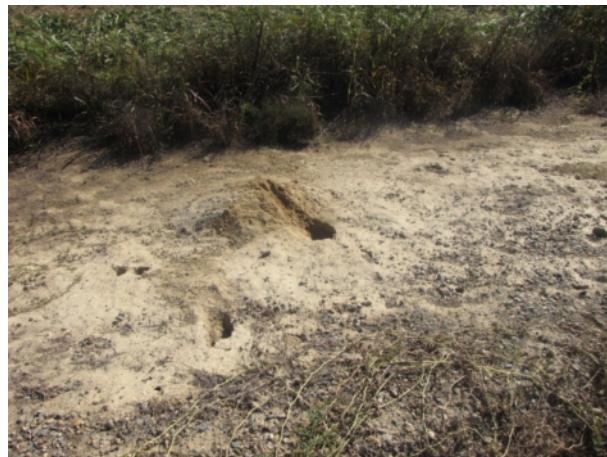
Levee Mile Report Line	10
Start Levee Mile	1.69
End Levee Mile	1.69
Location	Land Side
Category	Earthen Levee
Item	Animal Control

Looking east at squirrel holes on landside slope.

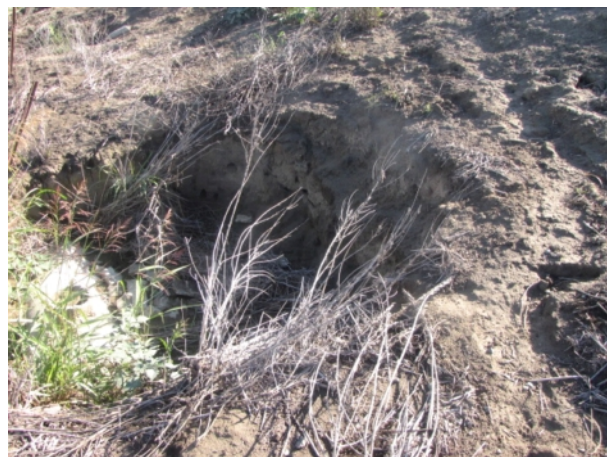
Levee Mile Report Line	11
Start Levee Mile	2.31
End Levee Mile	2.47
Location	Land Side
Category	Earthen Levee
Item	Erosion / Bank Caving

11	2.31	2.47	Earthen Levee	Erosion / Bank Caving	LS	U	Schedule repair of erosion site prior to the next inspection. Inspector Comments: Erosion is occurring around 10-12 inch concrete irrigation pipe at landside toe.	37.451927 ° -121.030555 °	37.450290 ° -121.028592 °	12 Y
12	2.56	2.56	Earthen Levee	Vegetation	LS	W	Remove the wild growth other than native grasses from the levee slopes.	37.449432 ° -121.027472 °	37.449432 ° -121.027472 °	13
13	2.72	2.79	Earthen Levee	Animal Control	LS	M	Repair the levee slope damaged by livestock and prevent large animal access.	37.447512 ° -121.026050 °	37.446574 ° -121.025643 °	982
14	2.78	2.84	Earthen Levee	Vegetation	LS	M	Remove the wild growth other than native grasses from the levee slopes.	37.446722 ° -121.025640 °	37.445925 ° -121.025528 °	14
15	2.87	2.90	Earthen Levee	Vegetation	LS	M	Remove the wild growth other than native grasses from the levee slopes.	37.445497 ° -121.025560 °	37.444985 ° -121.025622 °	15

Looking west at slope caving around concrete irrigation pipe on landside toe.

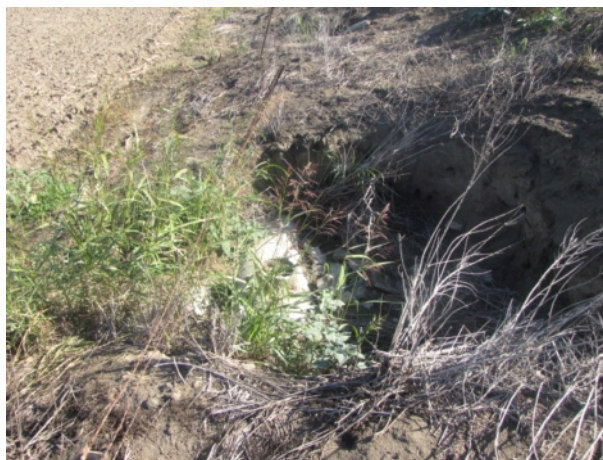
Levee Mile Report Line	11
Start Levee Mile	2.31
End Levee Mile	2.47
Location	Land Side
Category	Earthen Levee
Item	Erosion / Bank Caving

Looking south at additional caving around concrete pipe.

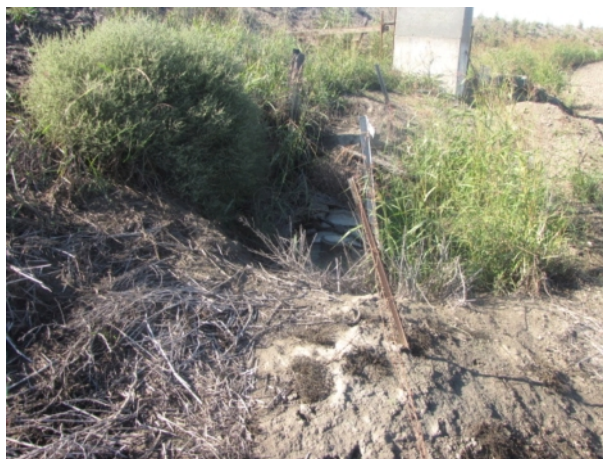
Levee Mile Report Line	11
Start Levee Mile	2.31
End Levee Mile	2.47
Location	Land Side
Category	Earthen Levee
Item	Erosion / Bank Caving

Looking north at site #1 caving around pipe on landside slope.

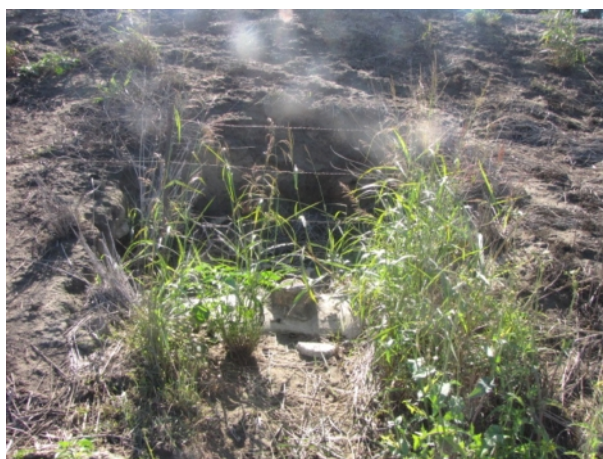
Levee Mile Report Line	11
Start Levee Mile	2.31
End Levee Mile	2.47
Location	Land Side
Category	Earthen Levee
Item	Erosion / Bank Caving

Looking west at caving around concrete pipe at site #3.

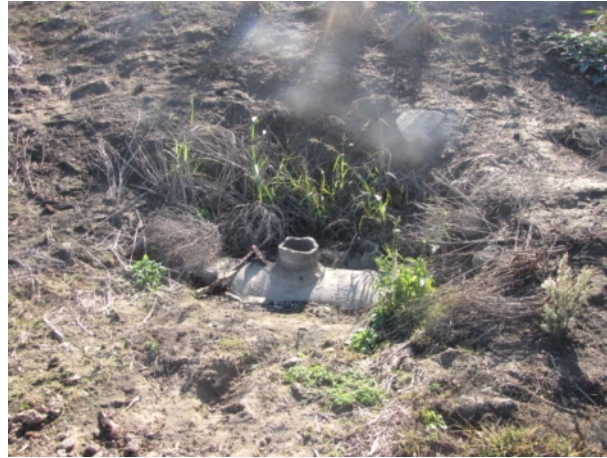
Levee Mile Report Line	11
Start Levee Mile	2.31
End Levee Mile	2.47
Location	Land Side
Category	Earthen Levee
Item	Erosion / Bank Caving

Looking west at concrete irrigation pipe that runs along landside toe.

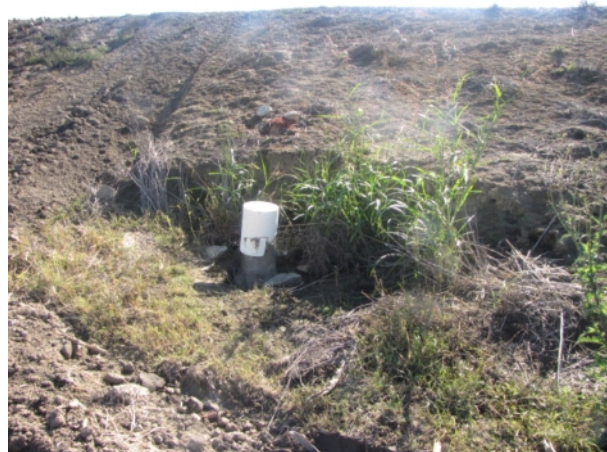
Levee Mile Report Line	11
Start Levee Mile	2.31
End Levee Mile	2.47
Location	Land Side
Category	Earthen Levee
Item	Erosion / Bank Caving

Looking southwest at site # 4 of slope caving around concrete irrigation pipe at landside toe.

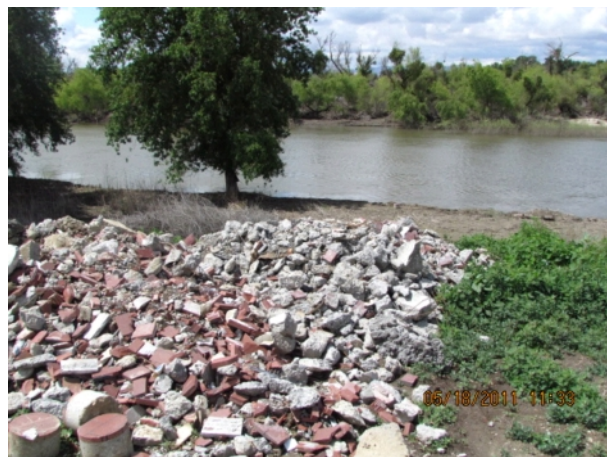
Levee Mile Report Line	16
Start Levee Mile	3.30
End Levee Mile	3.30
Location	Water Side
Category	Earthen Levee
Item	Encroachments

16	3.30	3.30	Earthen Levee	Encroachments	WS	M	Material Inspector Comments: Concrete rubble should be free of rebar before using on river bank.	37.441723 ° -121.021552 °	37.441723 ° -121.021552 °	28 Y
17	3.37	3.42	Earthen Levee	Vegetation	LS	W	Control annual grass and weeds on the levee slopes and easements.	37.440862 ° -121.020817 °	37.440237 ° -121.020372 °	16

Looking at concrete rubble on waterside shoulder with rebar.

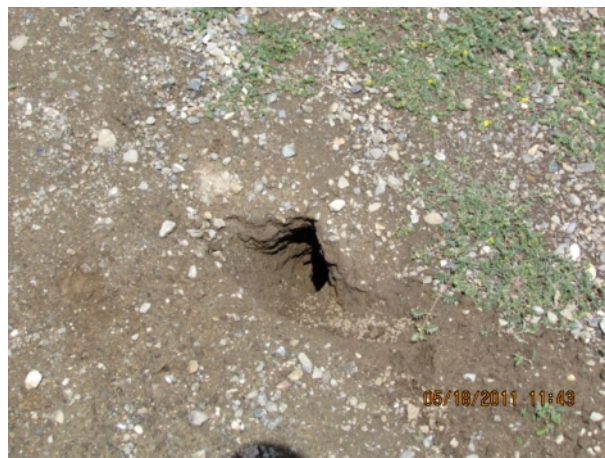
Levee Mile Report Line	18
Start Levee Mile	3.82
End Levee Mile	3.82
Location	Land Side
Category	Earthen Levee
Item	Animal Control

Looking at typical view or squirrel hole on landside shoulder.

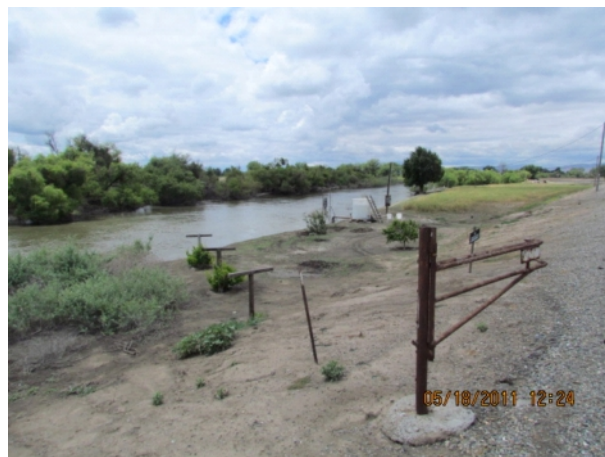
Levee Mile Report Line	21
Start Levee Mile	4.68
End Levee Mile	4.68
Location	Water Side
Category	Earthen Levee
Item	Encroachments

Looking south at grapevines and fruit trees on waterside berm.

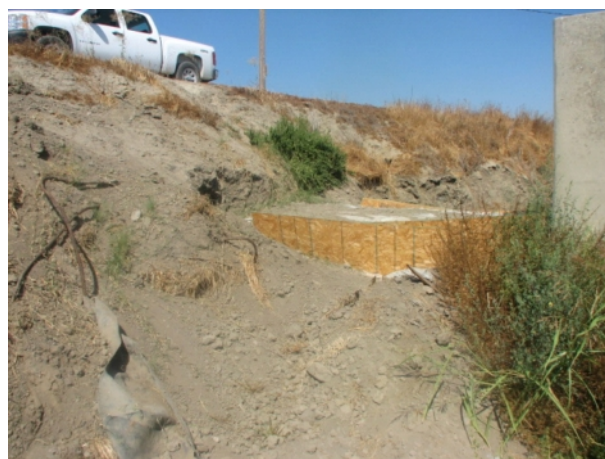
Levee Mile Report Line	25
Start Levee Mile	5.13
End Levee Mile	5.13
Location	Land Side
Category	Earthen Levee
Item	Encroachments

View of cut into landside slope

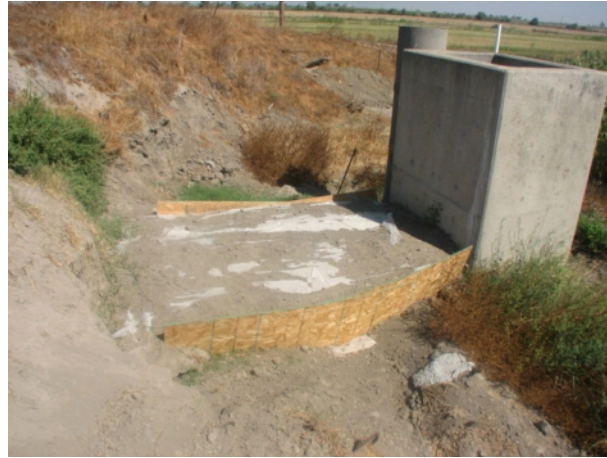
Levee Mile Report Line	25
Start Levee Mile	5.13
End Levee Mile	5.13
Location	Land Side
Category	Earthen Levee
Item	Encroachments

View of concrete stand pipe and encased pipe on landside toe.
